Holiday Inn Norwich - North

Guide Last Updated: 17/10/2017

Access Guide

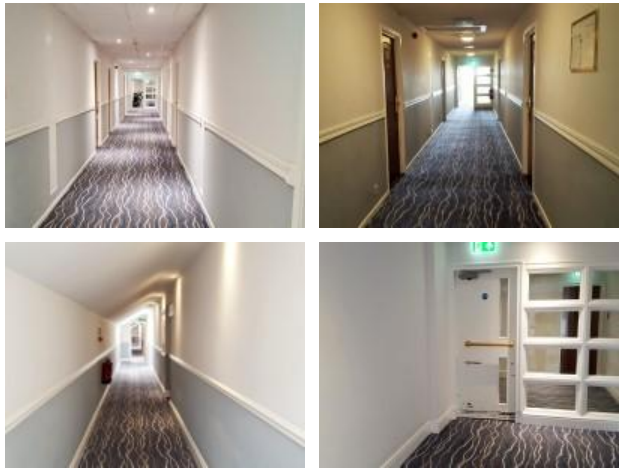
<p>Circulation</p> <p>Collapse -</p> <ul style="list-style-type: none"> • There are doors in corridors/walkways which have to be opened manually. • The type of flooring in corridors/walkways is carpet, tiles and laminate. • There is some flooring in corridors/walkways which includes patterns or colours which could be confusing or look like steps or holes to some people. • There is some flooring in corridors/walkways which is shiny and could cause issues with glare or look slippery to some people. • There is good colour contrast between the walls and floor in all areas. • The lighting levels are varied. • Access to other floors/levels is via stairs and lift.

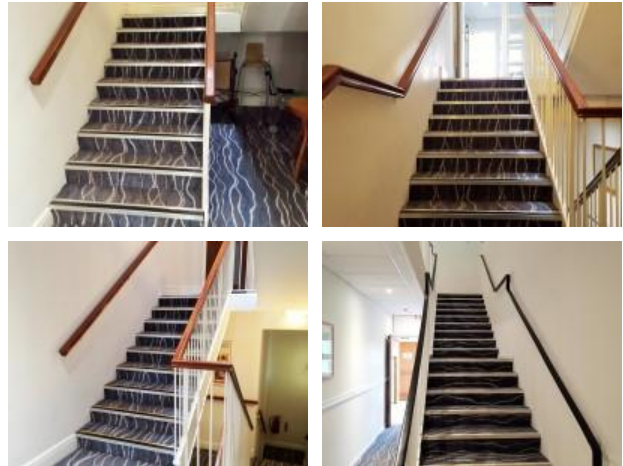
- Stairs can be used to access other floors.
- The stairs are for public use.
- The stairs are located to left as you face the reception.
- Signs indicating the location of the stairs are clearly visible from the entrance.

- The floors which are accessible by stairs are G, 1, 2 and 3.
- There are 15+ steps between floors.
- The height of the step(s) is/are between the recommended 15cm and 18cm.

- The going of the step(s) is/are not between the recommended 30cm and 45cm.
- The steps are clearly marked.
- There is a/are handrail(s) at the step(s).

- The steps have a handrail on both sides.
- Handrails are at the recommended height (90cm-100cm).
- Handrails do cover the flight of stairs throughout its length.

- Handrails are easy to grip.
- Handrails do not extend horizontally beyond the first and last steps.
- There is a landing.
- Clear signs indicating the facilities on each floor are not provided on landings.

- The lighting levels at the steps are good.

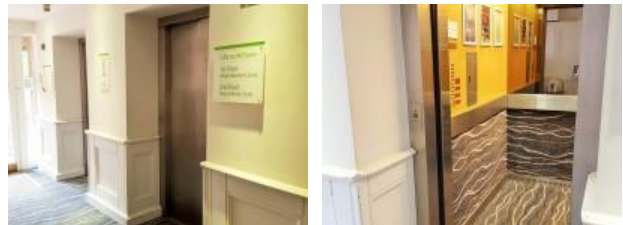
- There is a lift for public use.
- The lift is located to the left as you face reception.
- Signs indicating the location of the lift are clearly visible from the entrance.
- The lift is approximately 15m (16yd 1ft) from the hotel entrance.
- The lift is a standard lift.
- A member of staff does not need to be notified for use of the lift.
- The floors which are accessible by this lift are G, 1, 2 and 3.
- Clear signs indicating the facilities on each floor are provided on lift lobby landings.
- There is a clear level manoeuvring space of 150cm x 150cm in front of the lift.

- The external controls for the lift are within 90cm - 110cm from the floor.
- The colour contrast between the external lift controls and the control plate is poor.

- The colour contrast between the external lift control plate and the wall is poor.
- The clear door width is 80cm (2ft 7in).
- The dimensions of the lift are 105cm x 136cm (3ft 5in x 4ft 6in).

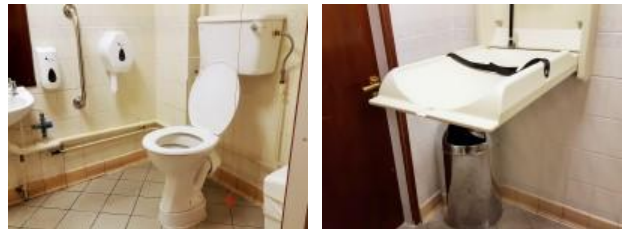
- The accessible toilet surveyed is not for the sole use of disabled people.
- This accessible toilet is located to the rear right of reception.
- This accessible toilet is approximately 14m (15yd 11in) from the hotel entrance.
- There is step free access to the accessible toilet.

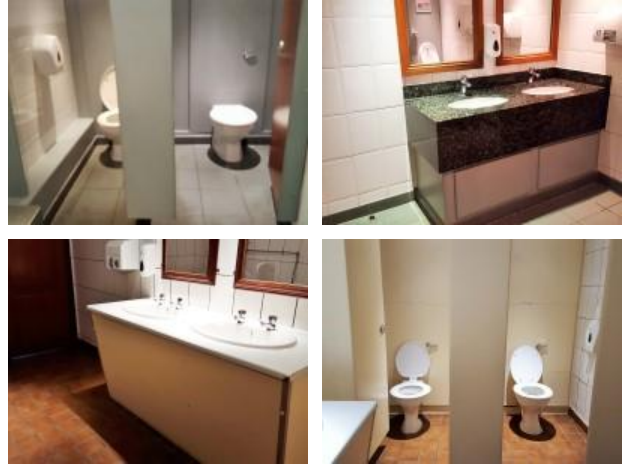
- The female and male toilet facilities that were surveyed are located to the right as you face the bar.
- The female and male toilets are approximately 9m (9yd 2ft) from the hotel entrance.
- There is step free access to the female and male toilet(s).
- There is pictorial signage on or near the toilet door.
- An ambulant toilet with wall-mounted grab rails is not available.
- The wash basin tap type is lever.
- There is not a flashing fire alarm beacon within the toilets.
- Lighting levels are good.
- There is a/are similar standard toilet(s) available.
